## Refurbishment Survey

Survey Reference Number: L-14437

St Grada and Holy Cross Church

Helston

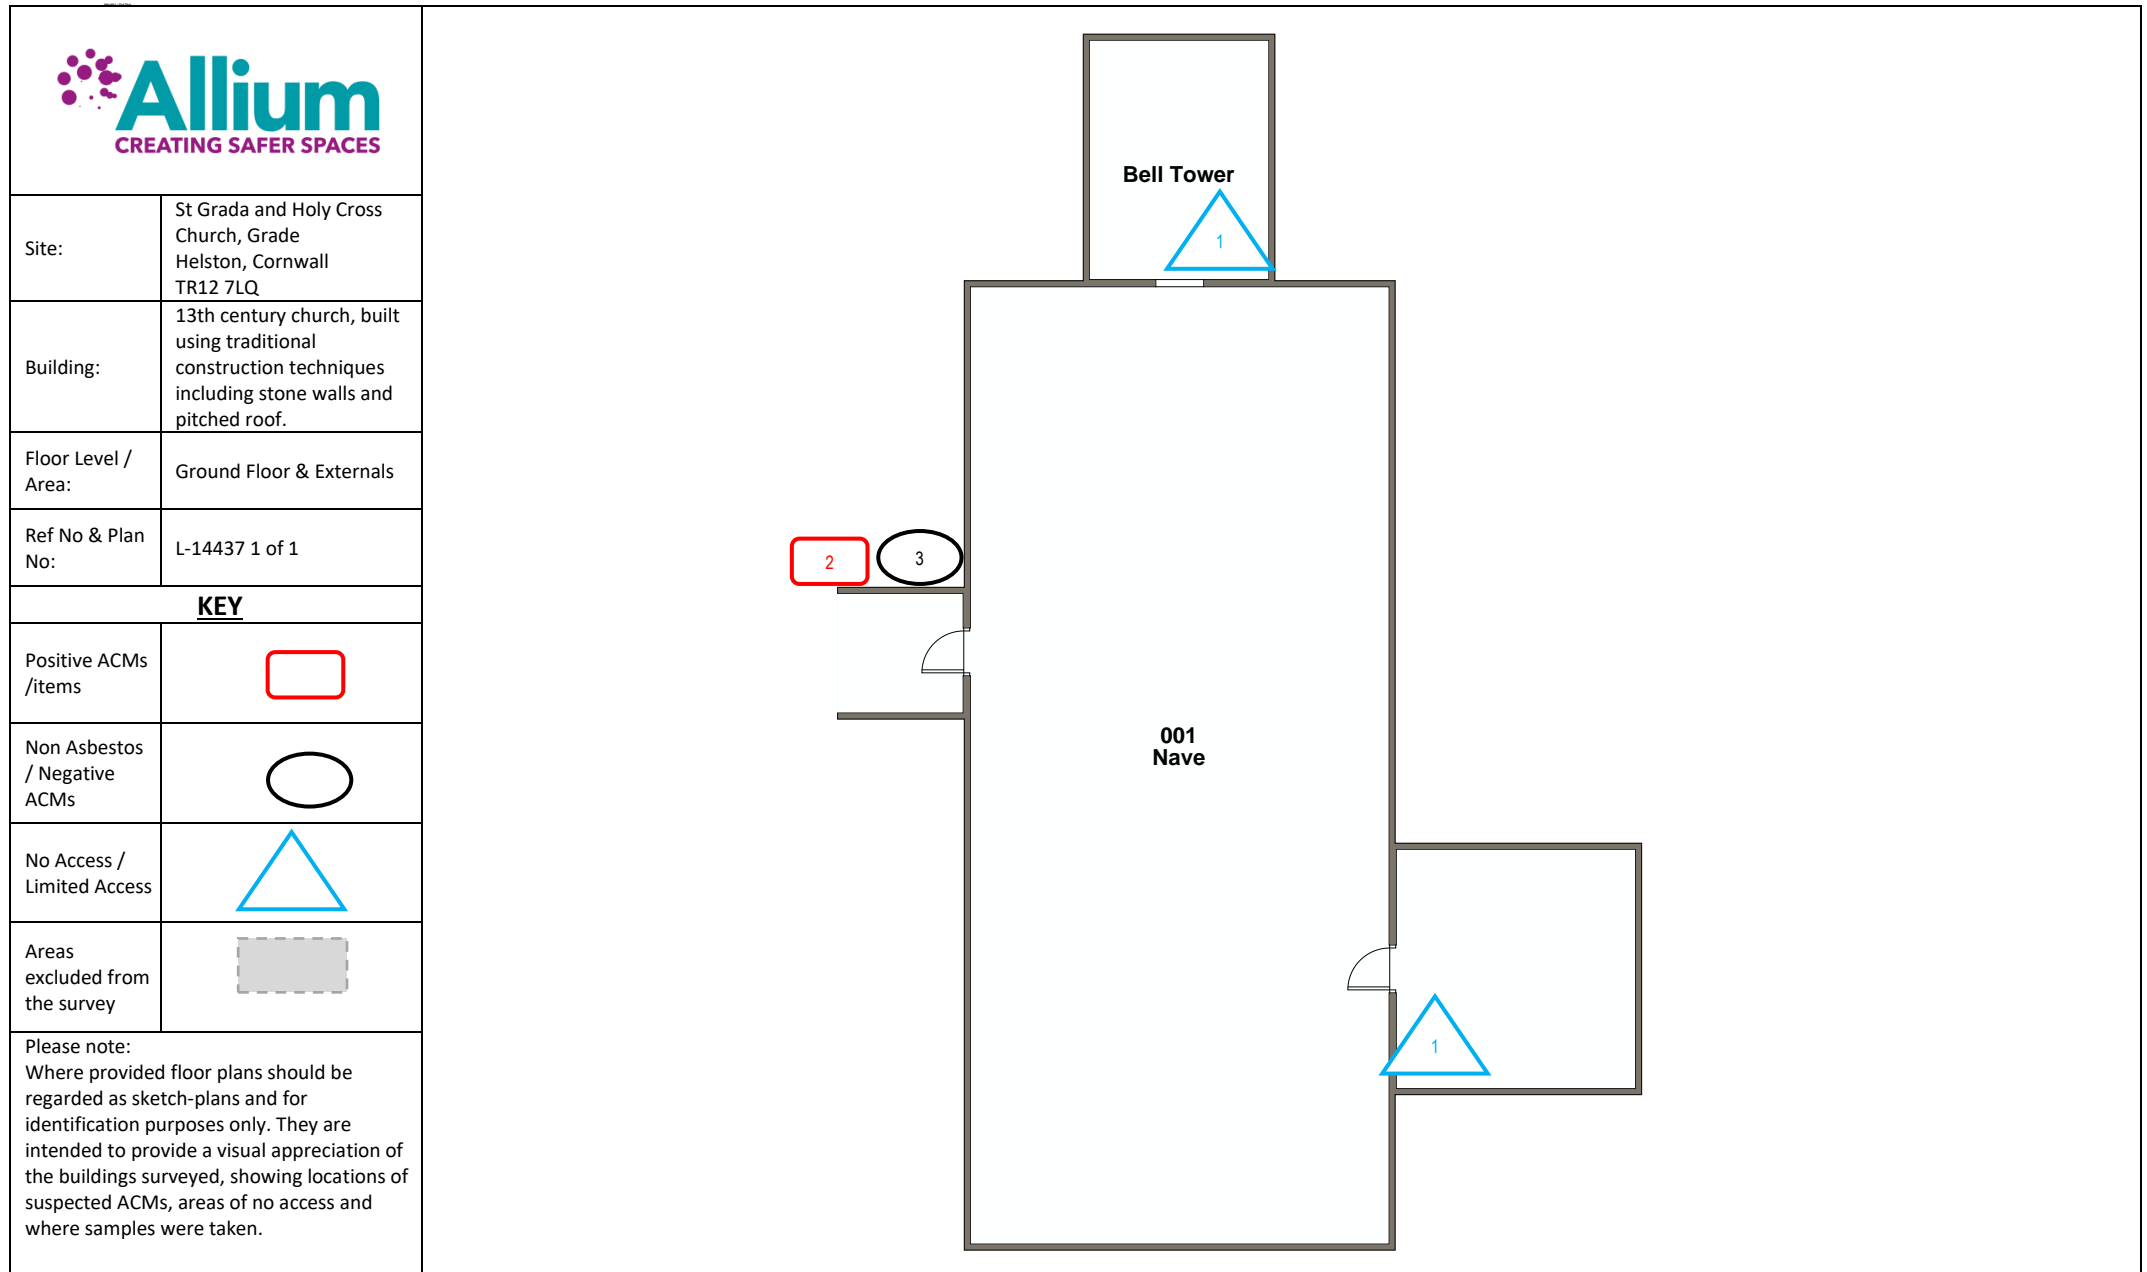
• THIS PLAN SHOULD BE READ IN CONJUNCTION WITH THE MAIN BODY OF THE REPORT AND INDIVIDUAL ITEM RECORDS
